CERN Press Release: Analysis of LHC Incident

Summary of the Analysis of the 19 September 2008 Incident at the LHC

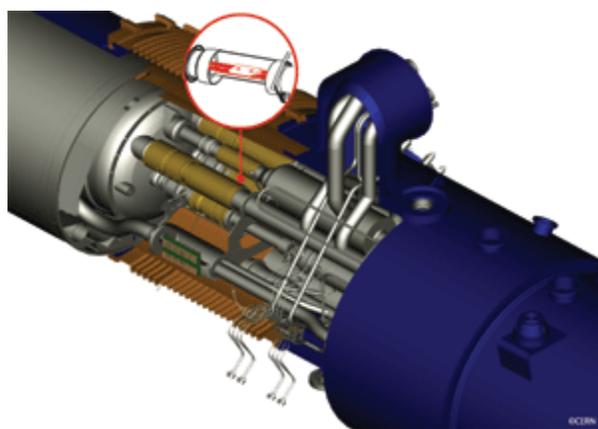
Geneva, 16 October 2008 (HE26). Investigations at CERN following a large helium leak into sector 3-4 of the Large Hadron Collider (LHC) tunnel have confirmed that cause of the incident was a faulty electrical connection between two of the accelerator's magnets. This resulted in mechanical damage and release of helium from the magnet cold mass into the tunnel.

Fig. 1. Investigations have shown that a faulty electrical connection between two magnets (shown in red) was the cause of the incident in sector 3-4 of the LHC on 19 September, 2008.
