# Superconductivity: its role, its success and its setback in the Large Hadron Collider (LHC) of CERN

**Lucio Rossi**

**Abstract.** The Large Hadron Collider - LHC, the particle accelerator at CERN, Geneva, is the largest and probably the most complex scientific instrument ever built. Superconductivity plays a key role because the accelerator is based on the reliable operation of almost 10,000 superconducting magnets cooled by 130 tonnes of helium at 1.9 and 4.2 K and containing a total stored magnetic energy of about 15,000 MJ (including detector magnets). The characteristics of the 1200 tonnes of high quality Nb-Ti cables have met the severe requests in terms of critical currents, magnetization and inter-strand resistance; the magnets are built with an unprecedented uniformity, about 0.01% of variation in field quality among the 1232 main dipoles which are 15 m in length and 30 tonnes in weight. The results of this 20 year long enterprise will be discussed together with problems faced during construction and commissioning and their remedies. Particular reference is made to the severe incident which occurred nine days after the spectacular start-up of the machine on 10<sup>th</s

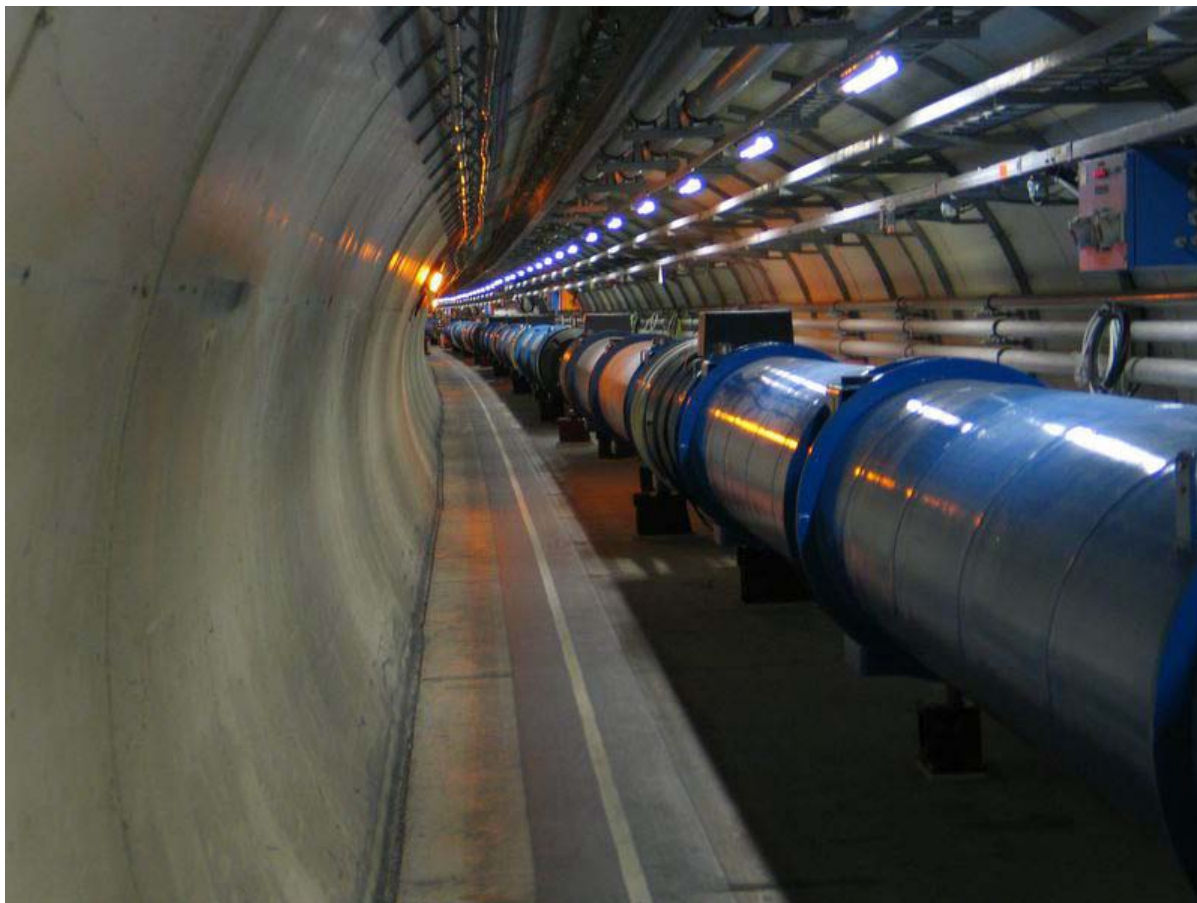
**Figure 1.** The superconducting magnets in the LHC tunnel

As previously mentioned, the main dipoles constitute the backbone of the machine: their maximum field determines in a direct way the beam energy and they cover 75% of the tunnel length: 65% with dipole magnetic field and 10% with electrical connections of various types. A further 10% of tunnel length is allocated to other types of magnets or magnet-related equipment: quadrupoles, sextupoles, octupoles, corrector magnets (from dipole up to dodecapole order), current feed-through boxes and other cryostat functions. The magnetic system in the LHC therefore covers in total 85% of the 26.7 km long beam path in the tunnel, see Figure 1.

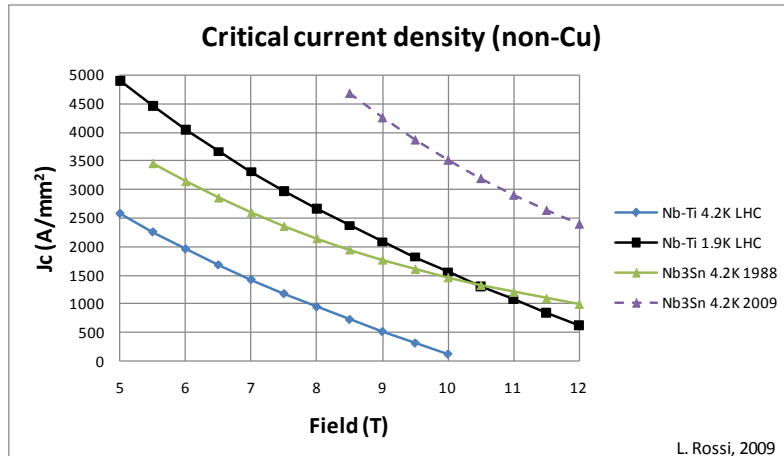
**Figure 2.** Current density of Nb-Ti and Nb<sub>3</sub>Sn at the time of LHC superconductor choice (about 1989). For information the recent Nb<sub>3</sub>Sn  $J_c$  is also reported, however its filament size is much larger.

At the beginning of the project, in the period 1985-90, two routes were pursued: Nb-Ti at 1.9 K and Nb<sub>3</sub>Sn at 4.2 K. The current density at that time was not so different in the 8-10 T region, see Figure 2.

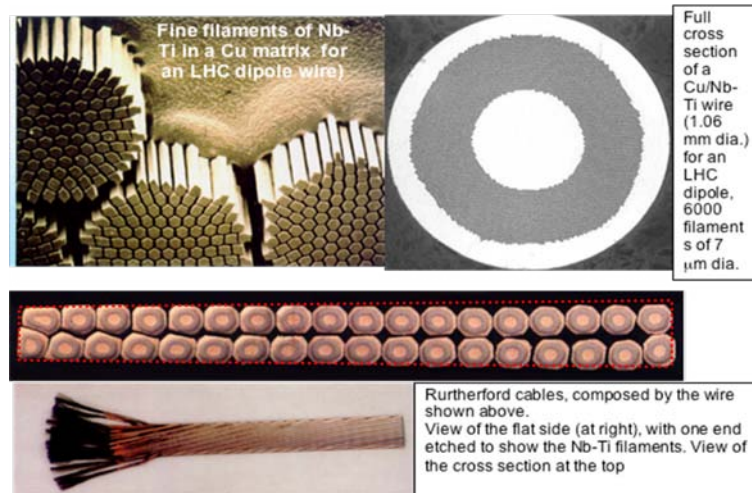
**Figure 3.** Typical wires and Rutherford cables employed for LHC magnets. The red dashed lines show the trapezoidal shape (keystone) of the cable cross section.

2nd. Maximise the compaction factor. The conductor is a Rutherford type, i.e. a flat two layers cable first proposed by Rutherford lab and used for the Tevatron magnets (Fermilab, USA). This allows a compaction factor (Area of strand/Area of the envelope of the cable) of around 90%, i.e. only 10% is lost in voids, the minimum to make the cable porous to helium. Rutherford cables are relatively simple and cheap to produce: cabling adds typically only 10% to cost of the strands. However there is always the risk of sharp edge and of current degradation due to strong deformation at the folding at the thin edge of the trapezoid, see Figure 3. The degradation of current density due to cabling is measured by comparing  $I_c$  before and after the cabling and for LHC has been negligible. The critical current measured on the entire production of the cable for the dipole inner layer (about 35% of the whole LHC production) is shown in Figure 4 [12].

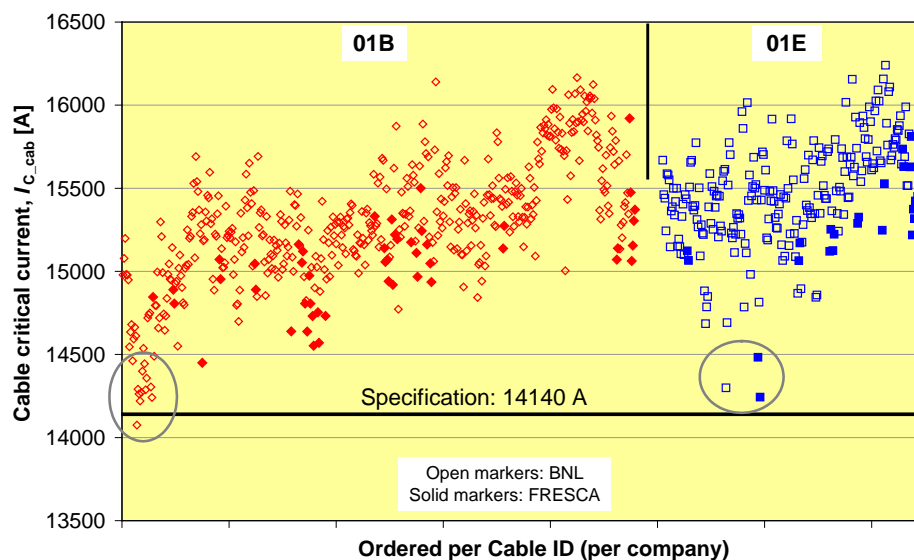
**Figure 4.** Critical current of the entire production of the largest LHC cable (two manufacturers), compared with specification. Weakest cables are indicated: for most cables the margin is more than 10%. Courtesy of A.Verweij, CERN.

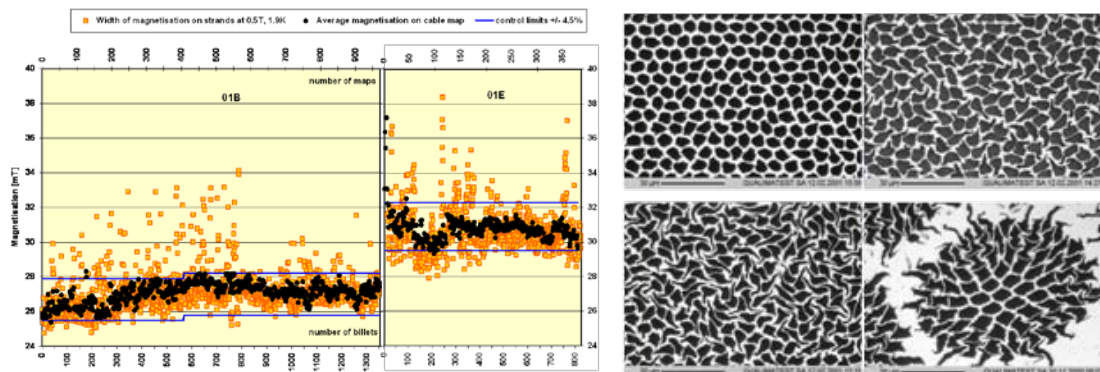
**Figure 5.** Magnetization measured in strands (orange squares) and the average in the corresponding cable (black circles superimposed), 5.a left; micrographs of cross section of the strands, 5b right, showing good filaments (top left) and cases of deformed filaments: the worst, bottom right, corresponds to  $\mu_0\Delta M > 35$  mT. Courtesy of S. Le Naour – CERN.

- The magnetization due to persistent currents. This very well known phenomenon is critical for LHC and can be detrimental for the machine performance with beam. Magnetization generates spurious fields, especially sextupole components –  $b_3$  – that at low field (when the beam is injected into LHC) must be accurately known and reproducible, to allow correction with small sextupoles magnets mounted on each dipole. Magnetization scales as:  $M \propto J_c \times D_{\text{eff}}$  where  $D_{\text{eff}}$  is the effective diameter of the superconductor filaments. Since we aim at the highest possible current density, the filament diameter must be minimised. For the LHC the main cables have 7  $\mu\text{m}$  and 6  $\mu\text{m}$  filament diameters, resulting in strands with 6000 to 8000 Nb-Ti filaments. The magnetization properties have been measured on samples from all billets produced for LHC and strict limits were fixed, with a specification of 28 mT of  $\mu_0\Delta M$  at 0.5 T. In Figure 5a the results for one cable are reported: it can be noticed that a number of billets (each measurement is a characterization of a billet) showed a magnetization value considerably in excess of the upper limit. However thanks to a good mixing of various strands in a cable, and thanks to the fact that most of the billets were well below the upper limit, the cable magnetization was almost always within specifications, which constitutes a great success of the superconductor manufacturing [13]. This was due to a careful design of the strands, an accurate control of the process and a massive testing campaign. Thorough analysis of jumps in magnetization, totally uncorrelated to other parameters like  $I_c$ , or even the n-value at transition, pointed to severe deformation of the filament (filamentation), see Figure 5b, and their origins were traced back to the hot extrusion process.

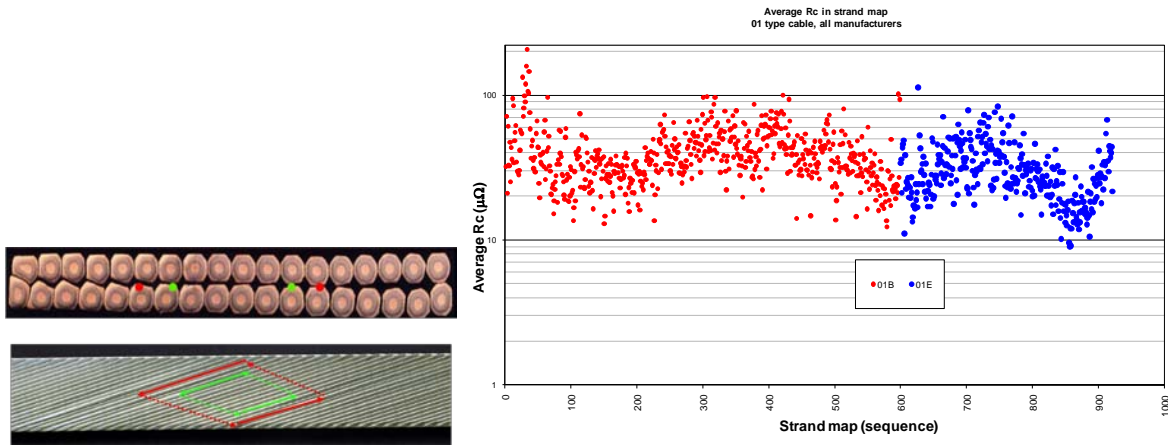
**Figure 6.** LHC Rutherford cable showing the path of induced current along strands and crossing points between upper and lower cable layer, 6a, left. The graphs on the right show the measurements on the production of inner cable of LHC (two producers), 6b, right. For inner cable the target was  $R_c > 10 \mu\Omega$ . Courtesy of D. Richter – CERN.

- The so-called dynamic properties:
  - *Inter-strand resistance*, i.e., the contact resistance  $R_c$  between strands composing the cable. The cable is squeezed in the coils, so the resistance among top and bottom strands in a cable is small, forming circuits with low resistance, see Figure 6a. When ramping up from low field to flat top field a current circulates in each loop generating heat (a negligible effect in LHC at the normal ramp of 7 mT/s) and field distortions. This dynamic effect on field quality may be very detrimental if the resistance of each contact is not above 10-15  $\mu\Omega$ . An R&D was therefore launched at the beginning of the project and a relatively simple and effective system was found to control the inter-strand resistance [13]. Wires are hot-dip coated with a thin layer of Sn-Ag (4%) and then, after cabling, the cable is thermally treated in air to form an oxide layer. Other systems, like direct oxidation of copper surface of the strands, were not suitable to obtain good and reliable results. Since a too low resistance has a visible dynamic

effect, the production could be successfully tuned to stay above the minimum limit, see Figure 6b.

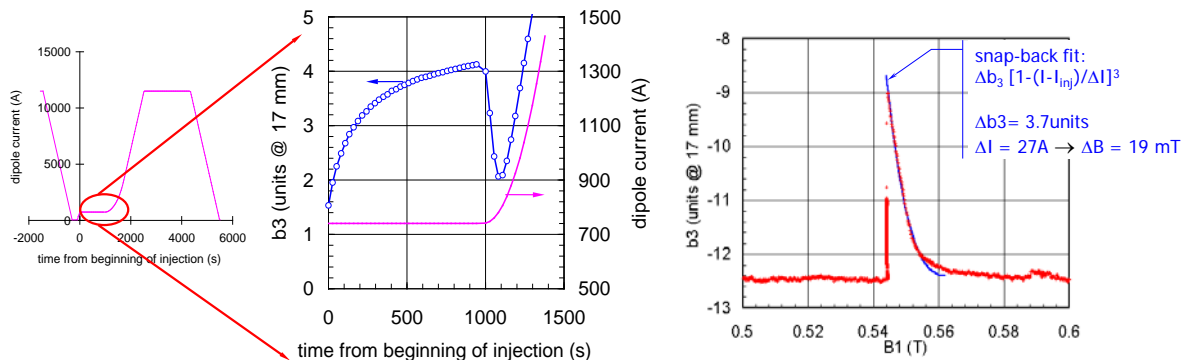
**Figure 7.** Illustration of snapback: the cycle of LHC requires a flat bottom of about 1000 s at about 730 A (or 0.54 T), see left graph. During the flat bottom the magnetization decays causing the

sextupole b3 to change of 3 units at constant main field, see central graph. When current starts ramping up, b3 snaps back suddenly. In the plot at the right the same is illustrated vs. dipole field rather than time and the scaling law fit is shown. Courtesy of L. Bottura – CERN.

- The second important dynamic effect is the so called snapback, a strange phenomenon that may plague accelerator magnets (or indeed any superconducting magnet needing precise field at low current after a cycle at high current). During the flat bottom at 0.54 T, the persistent currents slowly decay and so does magnetization, generating a decay in the sextupole components,  $b_3$ , of the field. This decay is slow and the change of  $b_3$  can be easily dynamically compensated by varying the strength of the sextupole corrector magnets. However, once beam injection is finished and the field starts ramping up to follow the beam energy increase, the magnetization value “snaps back” to its previous value before the decay. The jump in  $b_3$  is considerable in amplitude and, since it happens in a span of a few amperes, compensating it is not easy. The amplitude of the jump varies with the cable and is impossible to predict it for each type of cable – the mean value and its variance had to be carefully evaluated from a limited set of magnet measurements in order to set up a pre-programmed  $b_3$  correction by dedicated sextupole families. For the LHC a scaling law capable of describing the snapback behaviour has been successfully worked out, as shown in Figure 7.

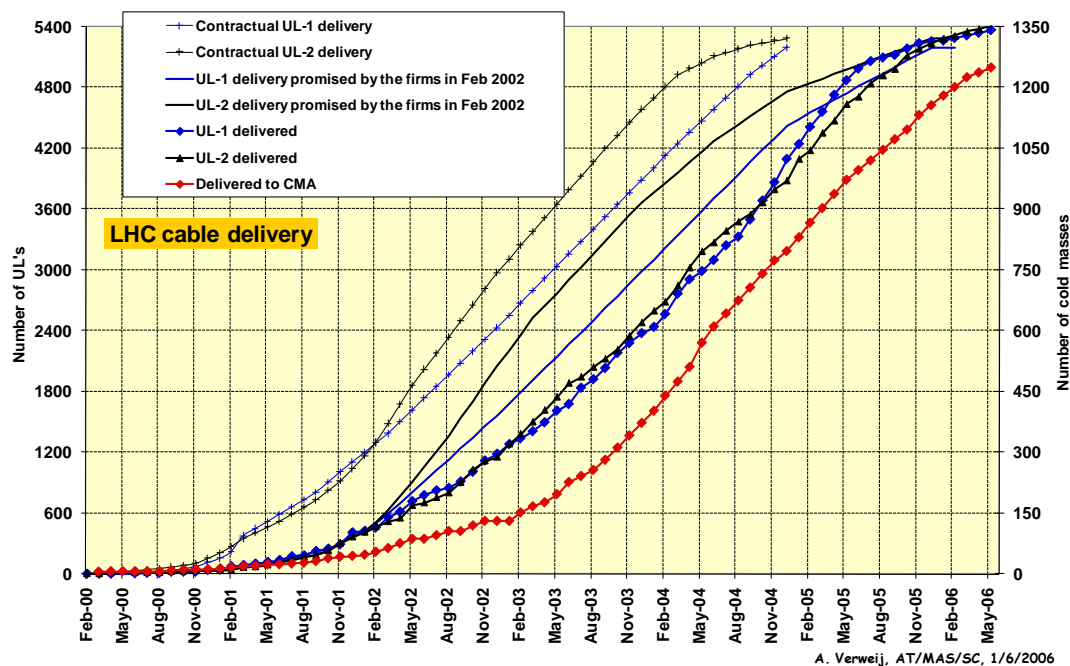
**Figure 8.** Delivery of the LHC main superconducting cables unit lengths (UL1 = cable for dipole inner layer; UL2 = outer layer). The most important feature is that from beginning 2002 the cable delivery was in advance to the needs of magnet companies CMA (Cold Mass Assemblers).

The problem of breakages as well as technical problems like a proper setting of the tinning or of cabling parameters, were the main bottlenecks for cable production. For almost two years the cable delivery was on the critical path of the project; however, from 2002 the production took off, and from then on it was never again a critical issue. The success of the cable delivery is summarized in the graph of Figure 8.

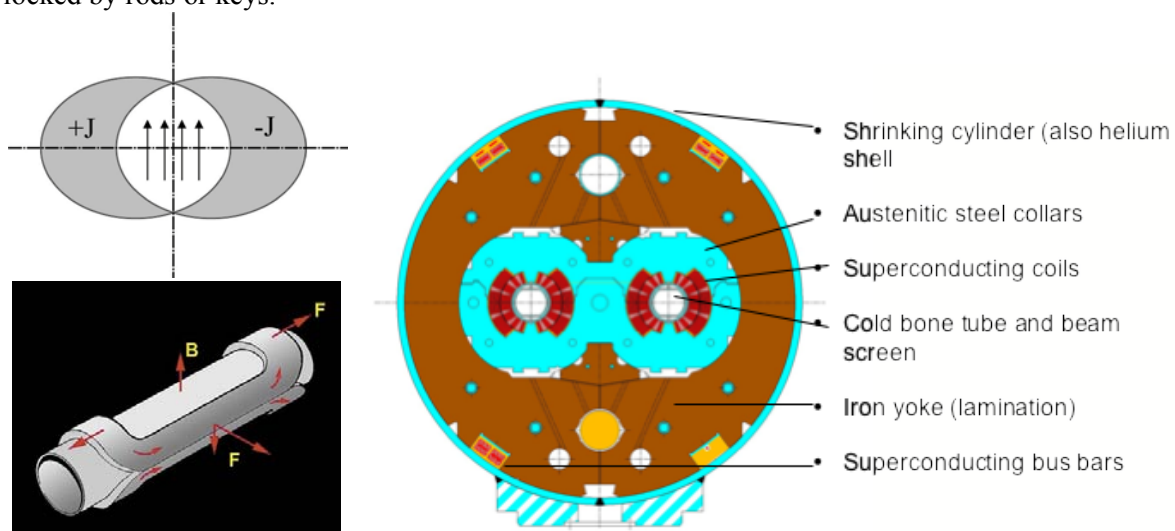
**Figure 9.** Sketch of an ideal dipole, cross section and coil shape, left; Cross section of the LHC dipole with its main components, right.

As mentioned, the most important type of magnet in the accelerator is the dipole, which produces a uniform transverse (to beam direction) field. The field is created by coils that present a distribution with maximum current at the mid-plane and zero at the pole, called  $\cos\theta$  current distribution. The coil shape is illustrated in Figure 9. The field given by such distribution is:  $B \propto \frac{1}{2} J d$ , where  $d$  is the coil thickness and  $J$  its current density. One should remark that this is exactly half of the field of a solenoid with the same basic parameter,  $J d$ . So clearly in a dipole configuration it is more difficult to reach high field than in a circular coil. Another consideration is more related to the structure of the magnet. As it can be seen in Figure 9, the electromagnetic forces are transverse to the coils, i.e., there is no internal stress that can compensate the forces. This requires that forces are fully supported by an external structure, which enhances considerably the difficulty when the level of current density and field is so high. Putting together the two above considerations in a practical way, see Figure 9, one can see that a dipole for accelerator is a crust of coil where one or two layers of conductor is disposed to approximate a  $\cos\theta$  distribution and is held by a system of collars tightly surrounding the coils and locked by rods or keys.

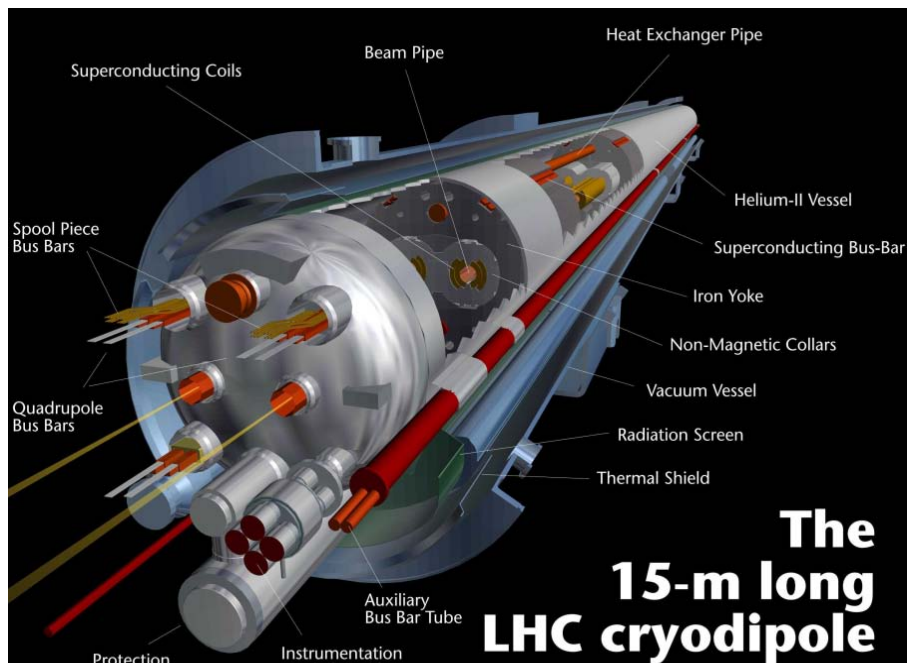
**Figure 10.** Schematic view of an LHC dipole with the main components indicated

The LHC tunnel has been inherited from the LEP (Large Electron-Positron collider, [26]) and is not large enough to accommodate two magnets side-to-side to guide the two particle beams. For LHC, the two magnets - each one with its own coil - are lodged in the same iron yoke. This is the basic “two-in-one” concept. This structure is also called “twin” if the coils, as in the LHC dipole, are fully coupled both mechanically and magnetically, as is clear from Figure 9. Initially devised as way to have a compact system, the “two-in-one” and its extreme “twin” version have been a real challenge because the design is more difficult and more sensitive to mistakes and tolerances. However, it has also contributed to a reduction of the cost with respect to a scheme with two separate magnets, for example the SCC design. We have evaluated the saving at about 15-20% of the cryo-magnet system, or about 10% of the total project cost, which was a key point at the time of approval in 1994-96. In Figure 10 a 3-D sketch of the LHC dipole in its cryostat is shown.

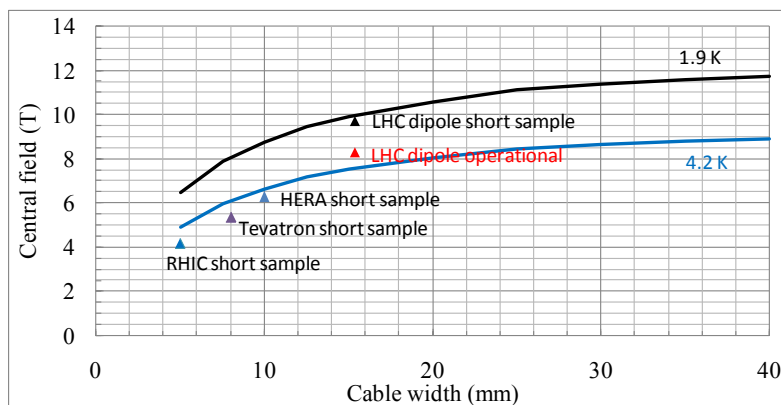
**Figure 11.** Theoretical scaling law for dipoles based on Nb-Ti superconductor and cos $\theta$  design, with LHC and previous accelerator projects indicated.

LHC magnets are the last product of a 30 years rush toward high field. As mentioned previously, the current density is the basic property for dipoles (and even more for quadrupoles). Indeed, as shown in Figure 11, any further increase in the dipole field of the LHC, with the same operative working point of 86% of the maximum theoretical current, would have required a very wide coil with an inefficient use of the superconductor [27].

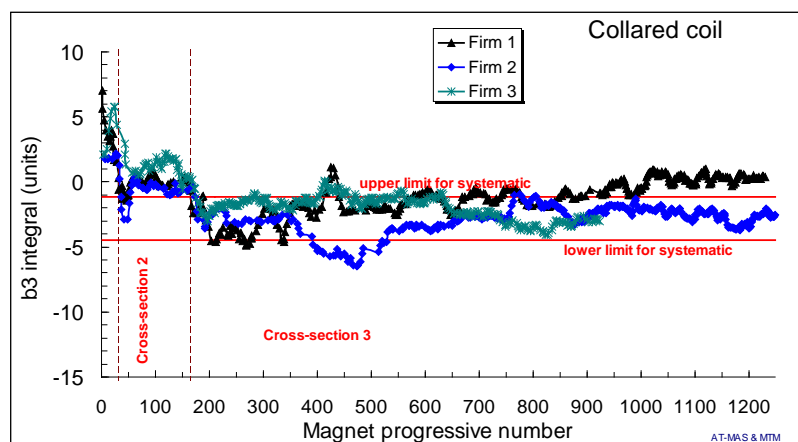
**Figure 12.** Sextupole components of LHC main dipoles as measured at room temperature ( $I=8$  A) in industry during construction. The two interventions for changing the cross section are indicated by vertical dashed lines. Courtesy of E. Todesco – CERN.

The quality of all the main steps has been characterized by measurements, tests and controls. The most innovative has been introducing magnetic measurements as a cornerstone of the QA test plan[28]. They have allowed detecting at very early stage a difference between design and results in some basic harmonics and we could intervene to correct the coil layout by modifying the conductor spacing at the level of 100  $\mu\text{m}$ . Though small, these changes (at two different times) will be essential for the good performance of the accelerator. In Figure 12 the harmonic b3 (sextupole) of the LHC dipole measured at room temperature in the factories [29] is shown with the time of intervention indicated.

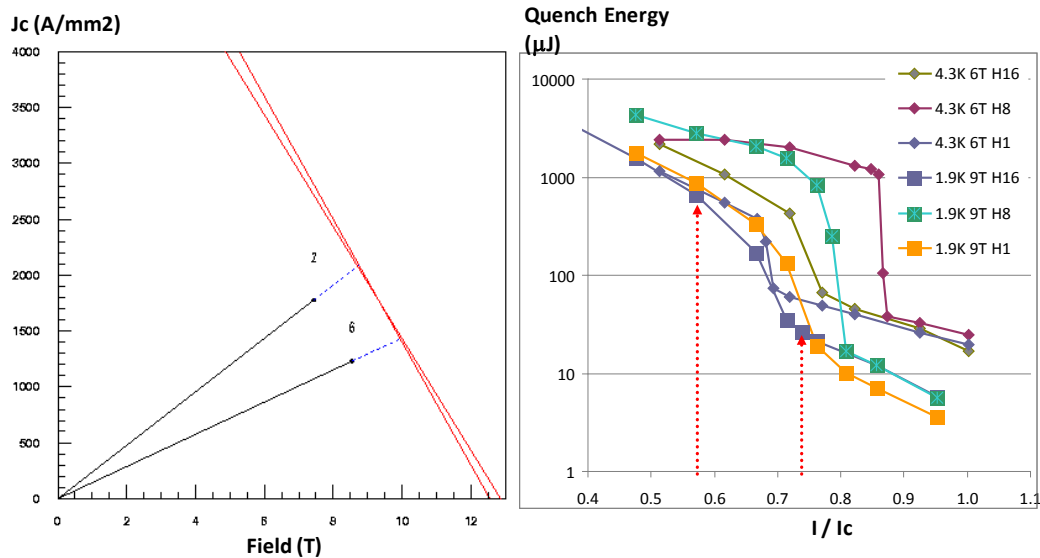
**Figure 13.** Load line of the LHC dipoles (left) and stability measurements (right). The most important are the large squares (1.9 K), namely H1 and H16, near the edge of the cable. Vertical arrows indicate operational point at nominal (8.3 T) and ultimate field (9 T). Courtesy of A. Verweij and G. Willering, CERN.

LHC dipoles work at  $I/I_c = 0.6$  at nominal 8.3 T central field (86% of quench current on the load line) and at  $I/I_c = 0.75$  at so called ultimate central field of 9 T (93% of quench current on the load line). It is not surprising that, despite the strong prestress, LHC dipoles are not very stable and that training is frequently needed to pass nominal field and that a long training is needed for ultimate operation.

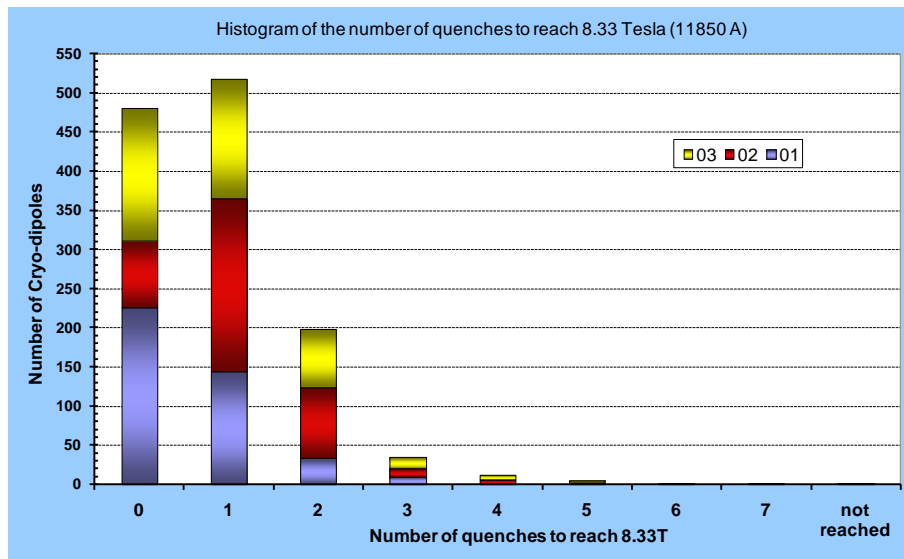
**Figure 14.** Quench performance to reach nominal field at first test. The different colours represent the three “families” of magnets, i.e. magnets from the different manufacturers. Courtesy of M. Pojer and A. Siemko – CERN.

For the limited number of magnets that have been submitted to a thermal cycle, either for checking or because they were the weakest, the number of quenches per magnet to reach the nominal field at second thermal cycle dropped, as expected, to 0.1-0.15, indicating that memory was important to improve the quench performance.

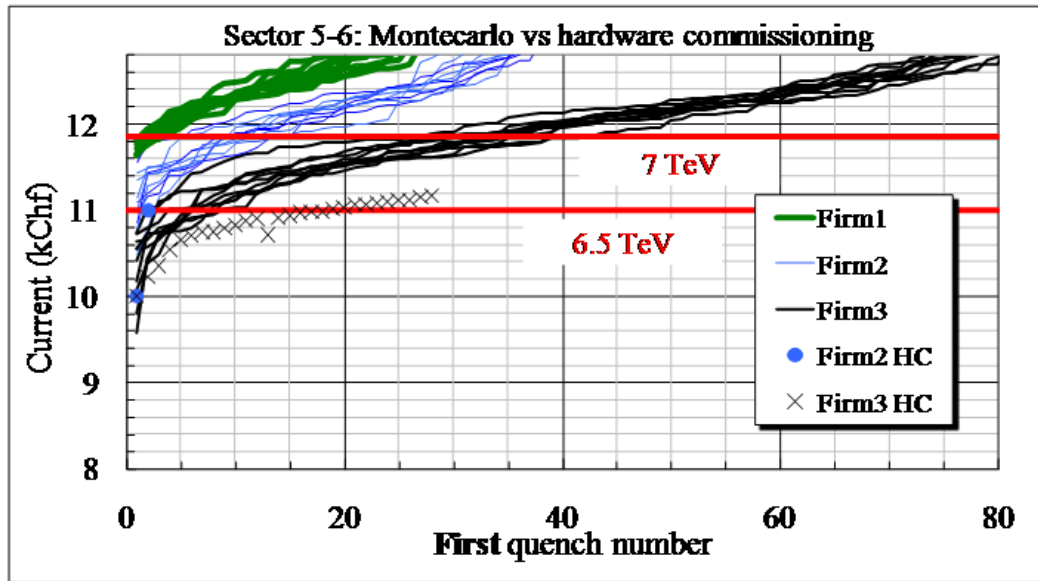
**Figure 15.** Forecast of quench performance of LHC magnets in the sector 5-6 (1/8 of the machine) inferred by acceptance test on surface, solid curves; actual performance during Hardware Commissioning (HC) of sector 5-6 (black cross or blue dot markers). Courtesy of E. Todesco, CERN.

During commissioning in summer 2008 we found that in the tunnel a family of installed dipoles presented a loss of memory higher than expected. In Figure 15, the forecast of quenches in the tunnel at LHC commissioning (based on the acceptance cold test) is reported for all three families of dipoles: the spread of the curves indicate the uncertainty in the analysis [39]. Markers show quenches actually experienced during the commissioning campaign before start up. For reasons we will explain later (symmetric quench) the dipole current in most sectors was limited to 6.5 T. Only the sector 5-6 was pushed up to 7.9 T. This sector contains a predominance of firm #3 magnets and for them the accentuated loss of memory was recorded. It can be seen that the “firm 3 HC” curve with cross markers stays well below the corresponding forecast from acceptance cold test. For the moment we do not understand the reason for this unexpected behaviour.

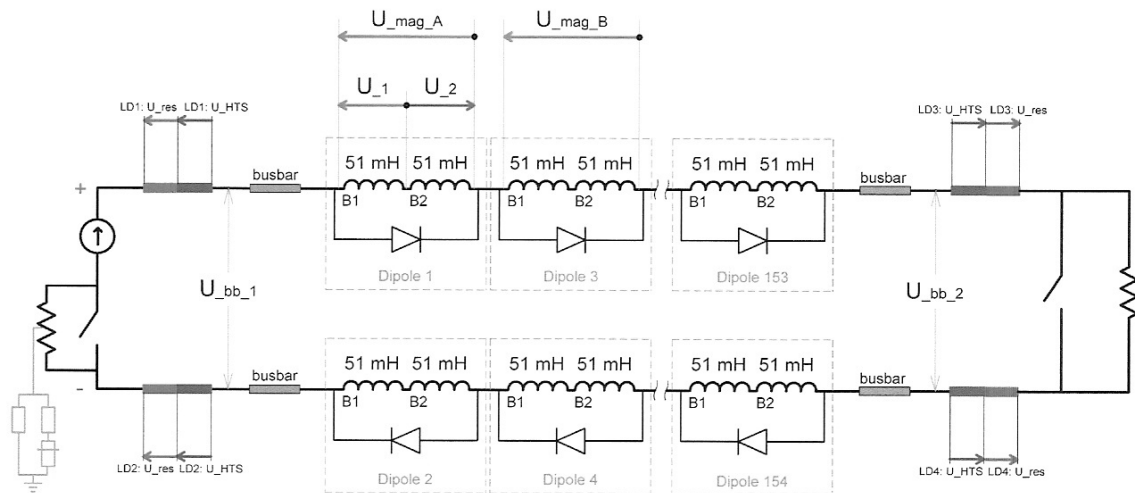
**Figure 16.** Protection scheme of the LHC magnets during operation (all series connected). The magnets are bypassed, in case of voltage rise, by the diode-bus bar system.

To fully understand the incident one needs to refer to the protection scheme [45]. A simplified version is shown in Figure 16; the 154 dipoles in a sector are all powered in series, with one power supply and a dumping resistor in parallel to all circuits, split into two resistors to lower the voltage-to-ground. When a quench is detected on a magnet the dump is activated through a switch. Given the inductance and resistance (determined by the current and maximum voltage) the  $1/e$  discharge time is 104 s, which is far too long for the magnet to survive. Each magnet therefore has a cold by-pass diode and heaters on the coils. As soon as a quench is detected the heaters are fired and the coils are quenched in less than 50 ms. The subsequent sudden voltage rise opens the diodes and the current in the quenched coils decays to almost zero in less than 1 s; meanwhile the whole line (all other magnets and the bus bars by-passing the quenched coils) is still carrying the full current. The bus bars, on which the diode is inserted, bypass electrically the whole magnet but serves also as connection between adjacent magnets. So during a magnet quench the bus bars carry the global circuit current, decaying with a time constant of 104 s, at the interconnections and in the quenched magnet(s).

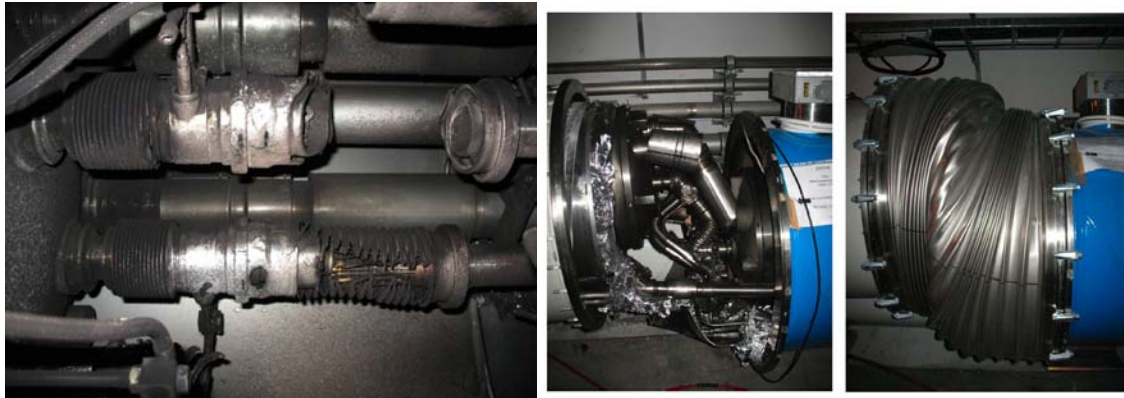
**Figure 17.** Pictures of the damaged zone after the incident. Left: zoom on the interconnection where the first arc happened, with vaporized cryogenic and vacuum pipes and soot deposited everywhere. Right: an interconnection between dipole (blue) and quadrupole (white) with interconnection bellow heavily deformed by displacement of the quadrupole against the dipole. Centre: the same interconnection after removal of the bellow.

A sudden increase of the voltage in the main dipole circuit was observed such that the power supply could not deliver the required current and a fast de-ramp with energy discharge on the dumping system was initiated. The discharge was faster than the nominal 104 s time constant and very soon the circuit was divided in two branches, clearly indicating the presence of a short circuit. Many magnets quenched and eventually helium was released into the tunnel and general power was lost in sector 3-4. At the first inspection in the tunnel, many magnets around the two where the defect originated were found to have been displaced with the interconnection bellows heavily damaged, see Figure 17. In the damaged zone (D-zone), primarily defined where the insulation vacuum was lost and about 750 m in length spanning from magnet Q19 to magnet Q33, considerable damage had occurred. There were deformation of connections, electrical faults (all, but the first, induced by mechanical displacement), perforation of the helium vessel, local destruction of beam tube with heavy pollution by debris from the electric arc and from fragments of multi-layer insulation (MLI), breakage or damage of cold support posts, breaches in the interconnection bellows and damage of the warm support jack sustaining the magnets, and cracks of the tunnel floor. The pollution of the beam tubes was much more extensive than the D-zone, spanning the full 3 km-long arc. The report of a task force set up by CERN to analyze the incident and propose possible remedies, is available in [46].

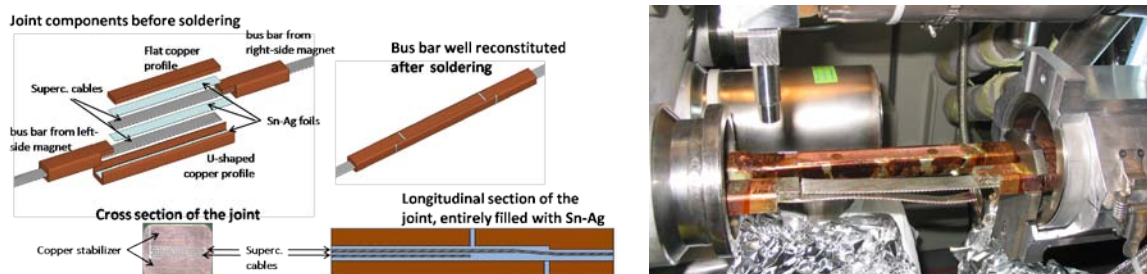
**Figure 18.** Sketch of the interconnection, showing the different components, left. A real interconnection under formation: there is always a bus bar pair in an interconnection. As-yet unconnected cables are seen in the foreground.

The dipole circuit interconnection had a defective joint between superconducting cables. A schematic of the 13 kA interconnection is shown in Figure 18. The technology is soft soldering based on tin-silver alloy, used both to splice the superconducting cable and to connect the copper stabilizer to the cable joint and to the stabilizing copper of the bus bar. When finished the connection looks like a continuation of the bus bars that run along the whole length of the magnet system.

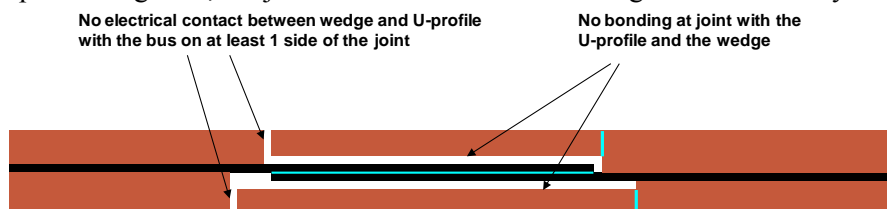
**Figure 19.** Scheme of the defective joint assumed to have caused the incident. Courtesy of A. Verweij.

The splice between superconducting cables is specified to have a resistance below  $0.6 \text{ n}\Omega$  at  $1.9 \text{ K}$  and the actual results on samples during production showed an average of  $0.2 \text{ n}\Omega$  with a variance of less than  $0.1 \text{ n}\Omega$ . The resistance of the splice that failed was later evaluated to be around  $220 \text{ n}\Omega$ . Unfortunately the quench detection system of the bus bars was not sensitive enough to detect the  $\sim 2 \text{ mV}$  voltage of the resistive zone; its sensitivity was in fact  $300 \text{ mV}$  with a  $1 \text{ V}$  intervention threshold. It was subsequently found that, during the plateau of current at  $7 \text{ kA}$  done the previous day, magnet temperature sensors had indicated a small but very clear  $40 \text{ mK}$  increase above  $1.9 \text{ K}$  - a clear sign of the existence of an abnormal dissipation of  $10.7 \pm 2.1 \text{ W}$ , corresponding to a resistance of  $180\text{-}260 \text{ n}\Omega$ . A thermo-electrical model was able to simulate a thermal runaway of the normal conducting zone in the splice at  $8.7 \text{ kA}$ , by making the hypothesis of a resistance of  $220 \text{ n}\Omega$  and no contact between cable

and stabilizer at the joint and also of a longitudinal gap in the stabilizer, see Figure 19. This discontinuity is very important as it impedes current sharing among cable and stabilizer. The time constant of the current decay in the bus bar is 104 s, while the copper of the cable is sized to withstand in resistive state a discharge time of 1 s, (what we have in a single magnet). If the above mentioned conditions are present together, the joint cannot sustain the discharge and melts away.

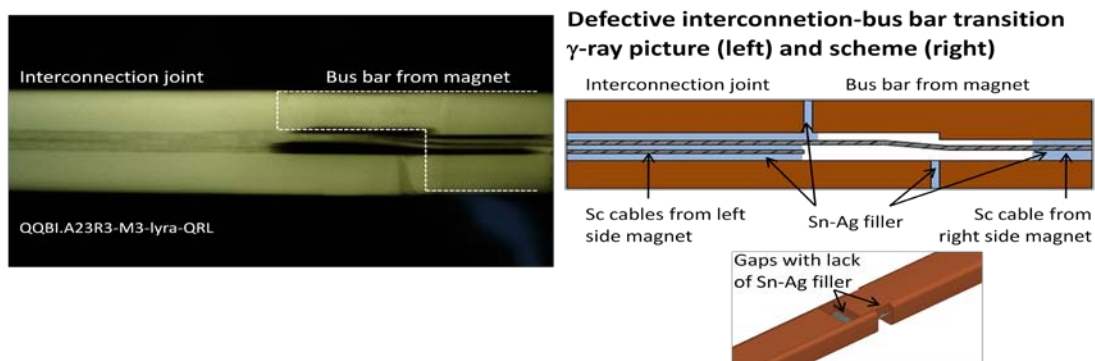
**Figure 20.** Defective interconnection (with SC cable detached from stabilizer). In the gamma-ray photo the two vertical gaps looks filled with solder, and so they are represented in the top right drawing: however, from electrical measurement, we infer they are actually open, like in right bottom drawing, so there is no continuity in the stabilizer and current has to flow in the isolated cable.

The above described measures do not fully protect against the fact that the splice between superconducting cables may be good but the surrounding copper stabilizer may not be in contact with the cable, as shown in Figure 20. Actually, if the stabilizer is in good contact with the superconducting cable but just has a small – a few mm – longitudinal gap there is no danger: in case of quench of the joint the current has to pass through the copper of the superconducting cable, however the small generated heat is easily evacuated to helium or to the bus bar though solid conduction. On the contrary, when this gap is coupled with a lack of tin-silver, i.e., the cable at the splice-to-bus bar transition is not in good contact with the stabilizing copper for a certain length, the situation can diverge. The current has to flow through the cable for the whole length where the cable is isolated and the heat may become too large to be evacuated without a large temperature rise and a thermal runaway is initiated, rapidly reaching the melting point in a few seconds.

The danger of the lack of stabilizer continuity was not immediately realized after the incident. The incident was triggered by a bad splice (i.e. bad SC-to-SC joint) generating internal heat; in the next run we will be able to detect bad splices with the new QDS and are protected against this failure. However, an interconnection joint can be quenched by external heating, for example by warm helium coming from a nearby quenching magnet. In such a case the lack of stabilizer continuity could cause a bus bar thermal runaway and is a subtler enemy than a bad splice, since it is more difficult to detect. A diagnostic method was implemented: by measuring a bus bar in its resistive state over a minimum length (2 or 3 magnets, i.e. 30 or 45 m) one can infer if there is a zone or zones where the cable is not in contact with the stabilizer in conjunction with a gap in the stabilizer itself. Unfortunately we could measure only in the four sectors that were warmed up. The four cold sectors had to be measured at 80 K with much less accuracy; as a result one of these sectors was warmed up in order to check a possible bad joint. In the four sectors where we had time to measure and repair, all bad joints where the defect was longer than 20-25 mm were fixed. However, in a fifth sector that was warmed up 3 joints only were repaired, leaving behind defects of almost 40 mm. In the three sectors which were not warmed up, due to uncertainty in the cold measurements, we cannot exclude a 70 mm long defect.
